Purpose

Site specific field evaluation of proposed stands for commercial timber harvest, and the soil mapping units occurring at the stand level.

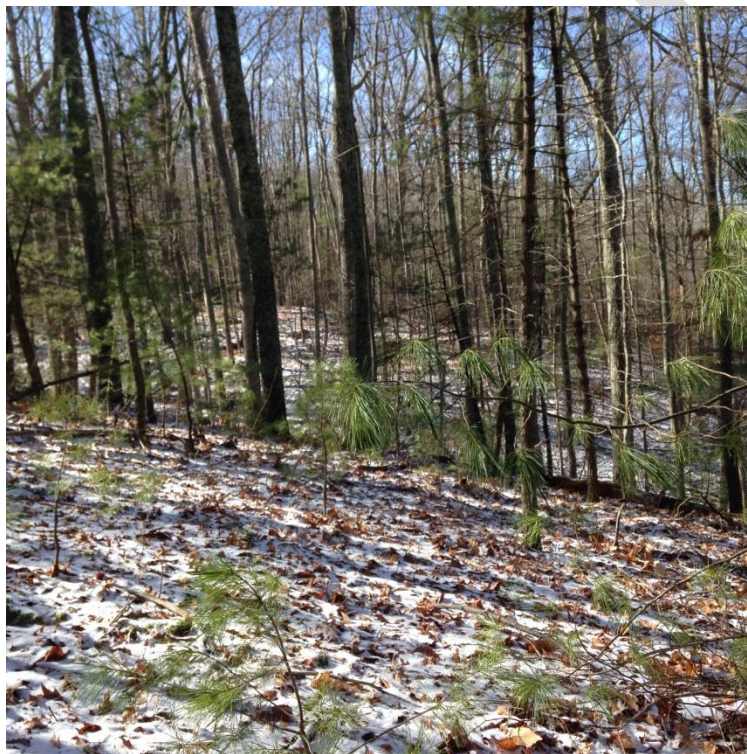
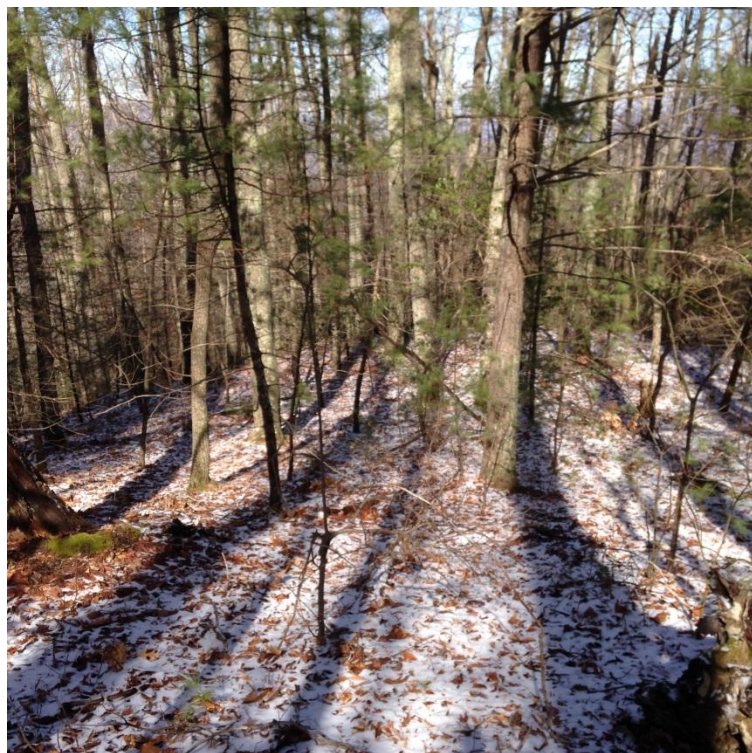
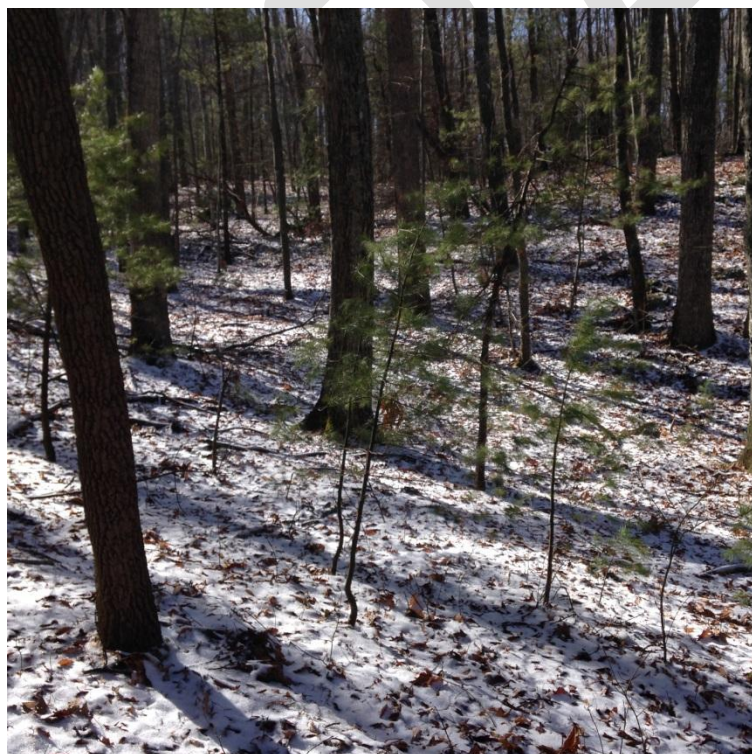
This stand is mapped primarily as Junaluska-Brasstown E (20-35%). Field investigation identified that the majority of the stand is dominated by “D” slopes (12-20%). Old skid roads through the unit are stable and at appropriate grades, making them suitable for use in the proposed timber harvest. One old skid road located within the streamside filter zone in this unit should not be re-used for this entry as it is not located in compliance with Forest Plan Standards.

Figure 32. Typical portion of 218/10 with grades of 15%-20% Area mapped as Junaluska-Brasstown “E”.

Figure 33. Typical portion of 218/10 with grades of 15%-20%. Area mapped as Junaluska-Brasstown "E".

Figure 34. Typical portion of 218/10 with grades of 15%-20%. Area mapped as Junaluska-Brasstown "E".

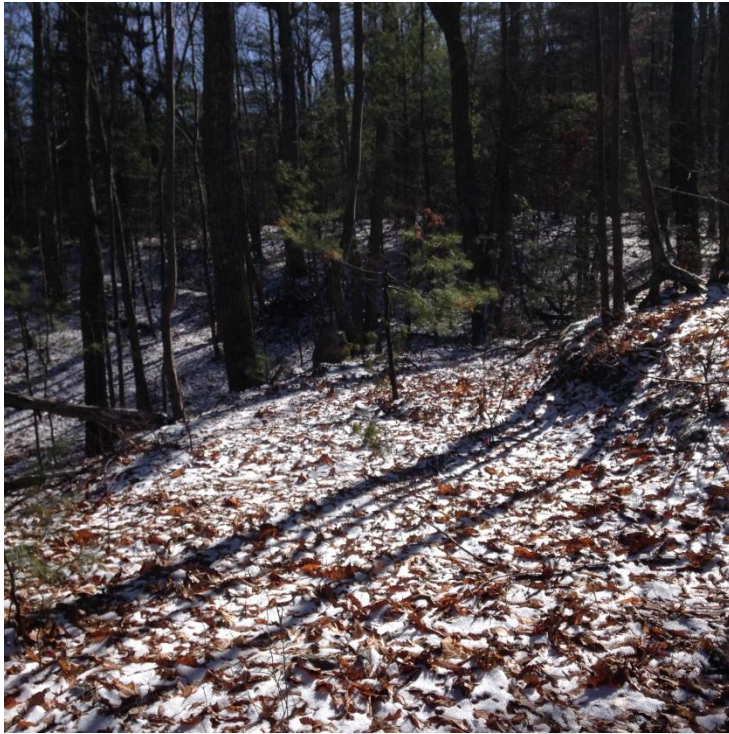
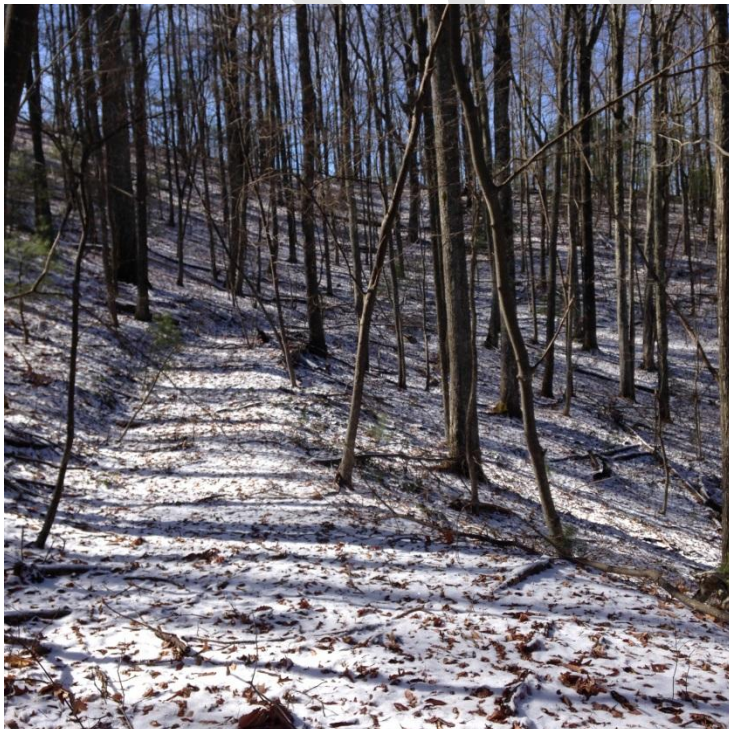
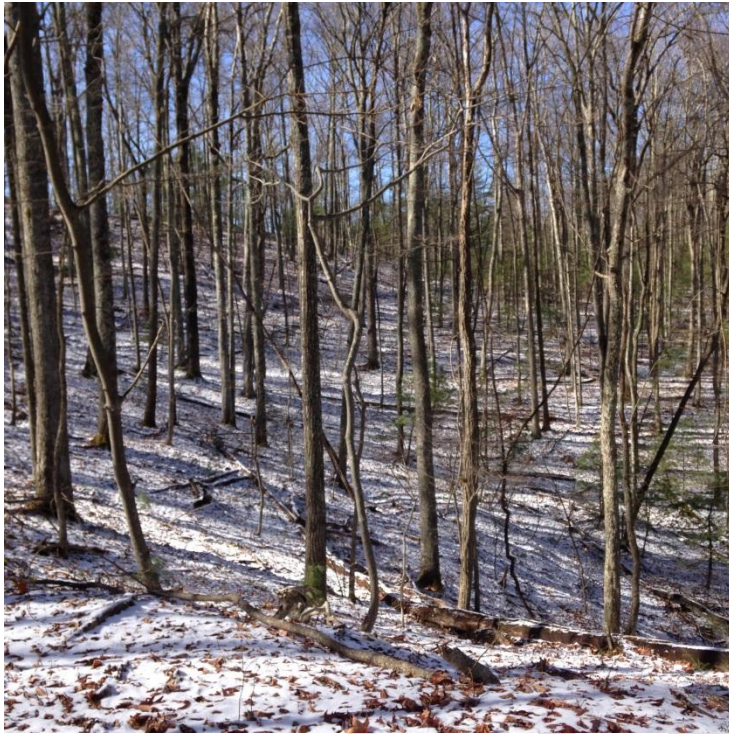
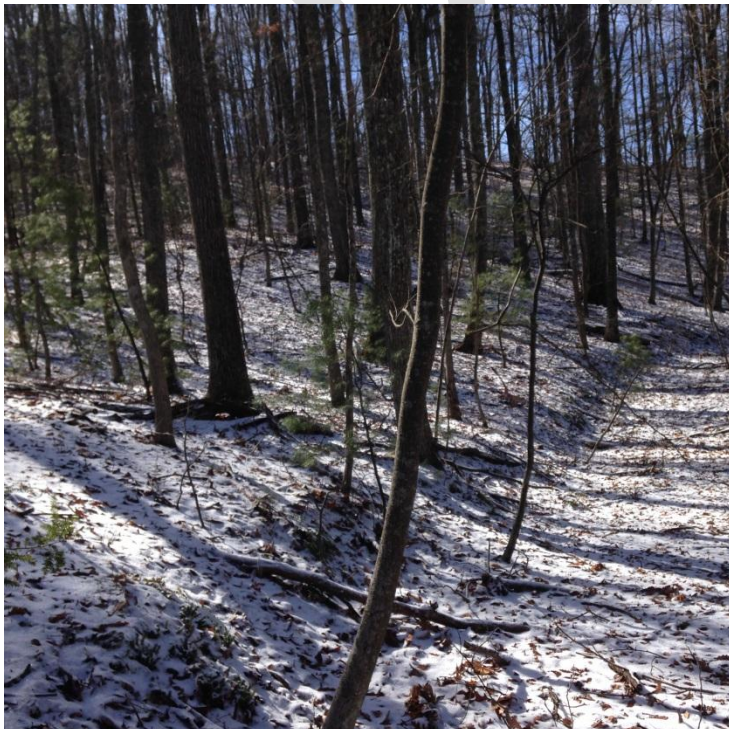
Figure 35. Old skid roads through the unit are stable and generally run at appropriate grades, making them suitable for use in the proposed timber harvest. Area mapped as Junaluska-Brasstown "E".

Figure 36. Old skid roads through the unit are stable and generally run at appropriate grades, making them suitable for use in the proposed timber harvest. Area mapped as Junaluska-Brasstown "E".

Figure 37. Old skid roads through the unit are stable and generally run at appropriate grades, making them suitable for use in the proposed timber harvest. Area mapped as Junaluska-Brasstown "E".

Figure 38. Old skid roads through the unit are stable and generally run at appropriate grades, making them suitable for use in the proposed timber harvest. Area mapped as Junaluska-Brasstown "E".

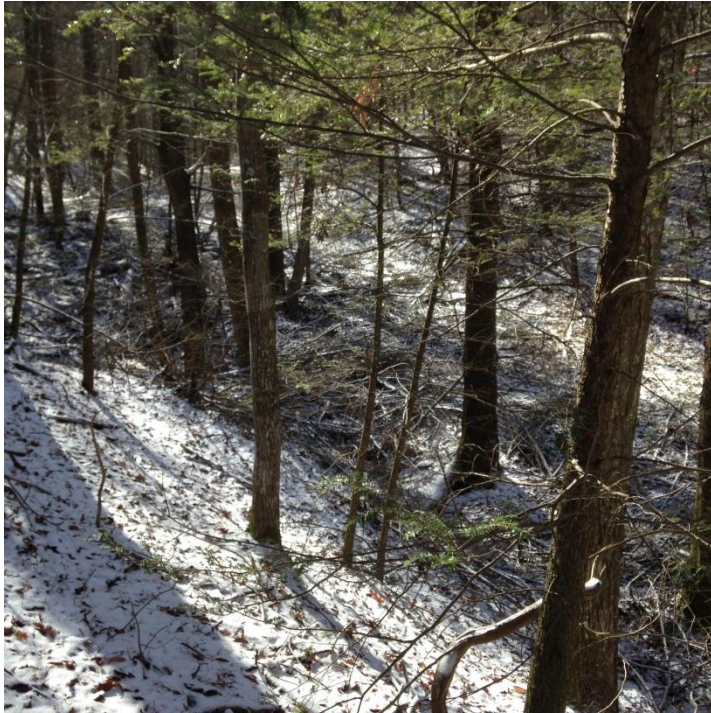
Figure 39. Equipment will be excluded from portions of the area mapped as Junaluska-Brasstown "F" that fall within the riparian buffer or streamside filter zone. The old skid road along the stream in this photo would not be re-used for this entry as it is not located in compliance with Forest Plan Standards.

Portions of the area mapped as Junaluska-Brasstown F in the northeastern corner of the stand will be closed to equipment since they fall in the riparian buffer. With respect to the areas mapped as Northcove F and Unicoi Rock Outcrop – equipment will be excluded from areas with slopes in excess of 40% in accordance with project design criteria.

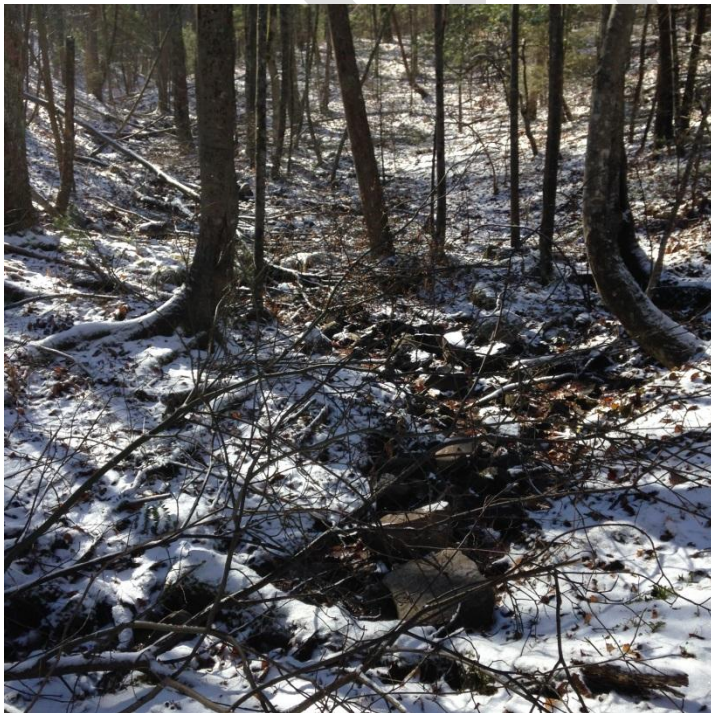
Figure 40. Equipment will be excluded from portions of the area mapped as Junaluska-Brasstown "F" that fall within the riparian buffer or streamside filter zones.

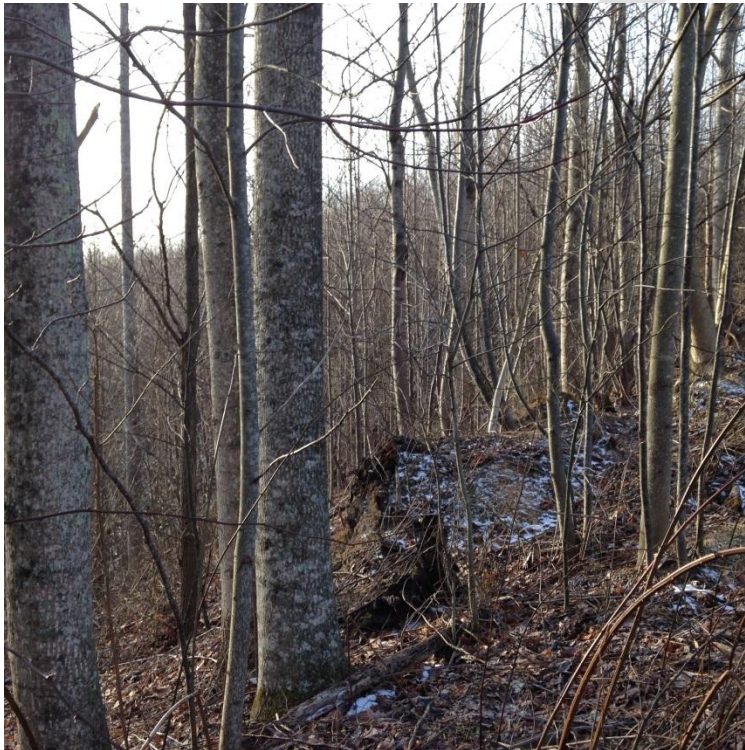
Figure 41. Edge of log landing and adjacent slope of 2005 sale on Ricker Mountain. Slope is stable. Area mapped as Junaluska-Brasstown "E".

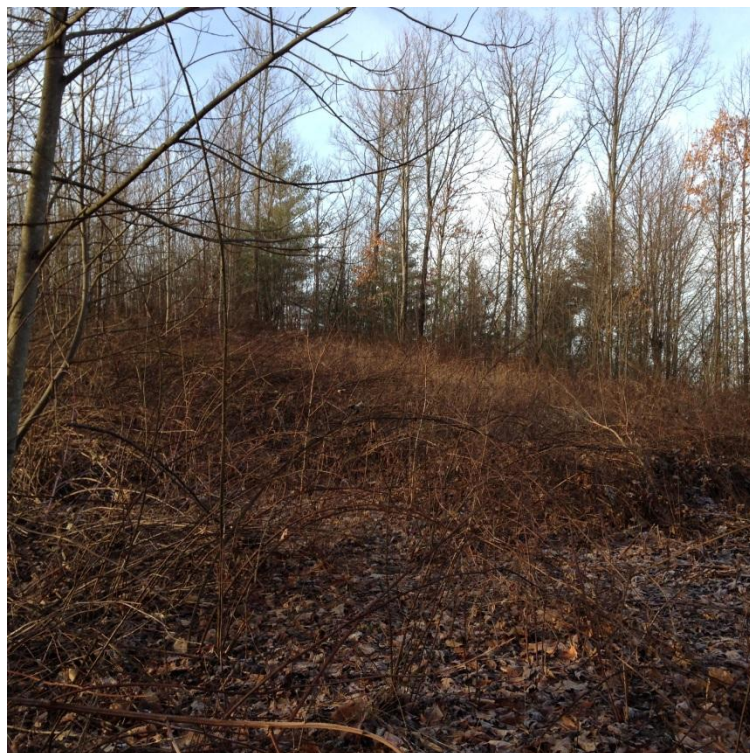
Figure 42. Log landing from 2005 sale on Ricker Mountain. Landing is stable and fully revegetated. Area mapped as Junaluska-Brasstown "E".

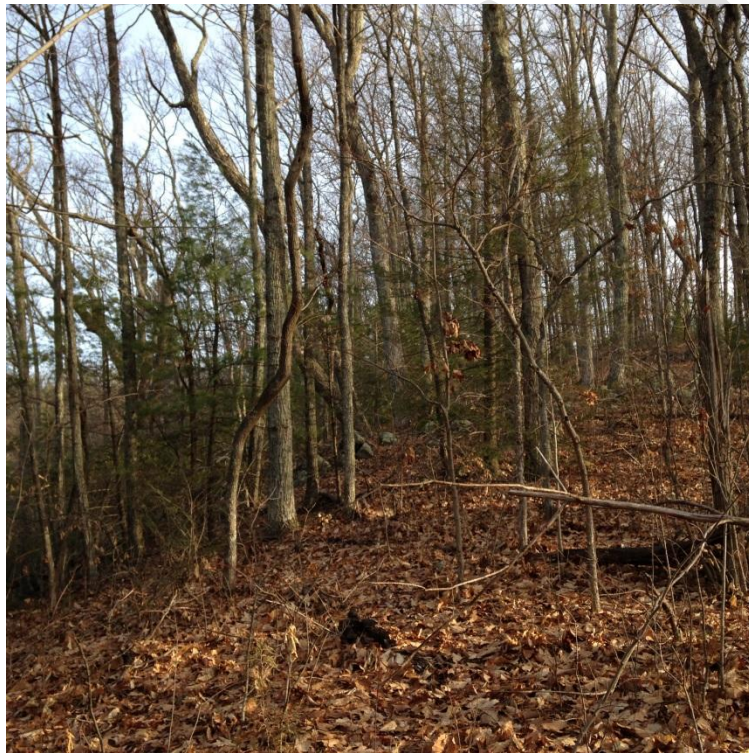
The slope of the main ridge running roughly north-south in this stand is approximately 35% at its steepest. The eastern face of the ridge is mapped as Unicoi Rock Outcrop but actually grades from approximately 60% slope at the southern end to approximately 15% towards the northeastern corner. The southwestern and western faces of the ridge are accurately mapped as “F” and “G” slopes.

Figure 43. Main ridge running north-south through 214/13. Area mapped as Junaluska-Brasstown “E”.

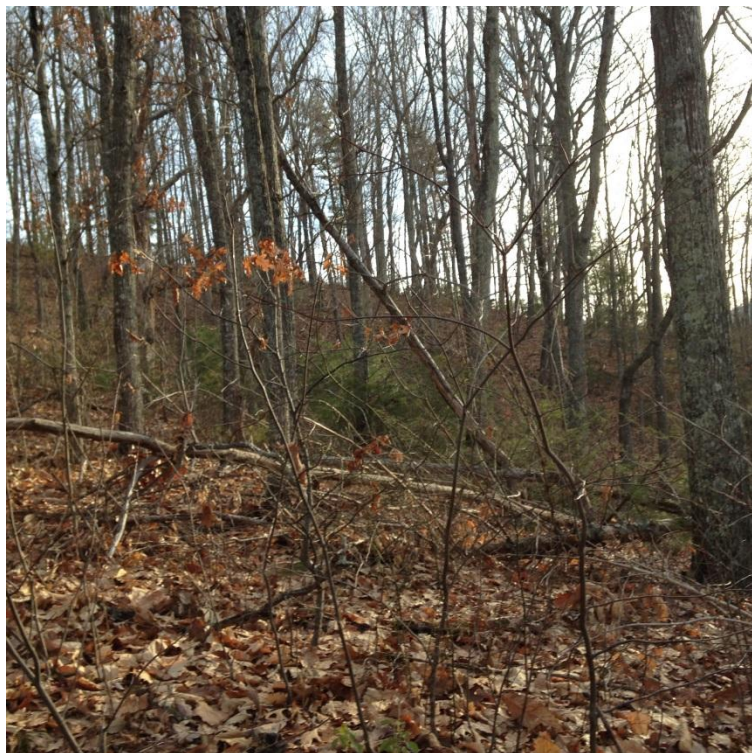
Figure 44. Looking east across area mapped as Junaluska-Brasstown F in 214/13. The area mapped as Northcove F is just to the right, out of the picture.

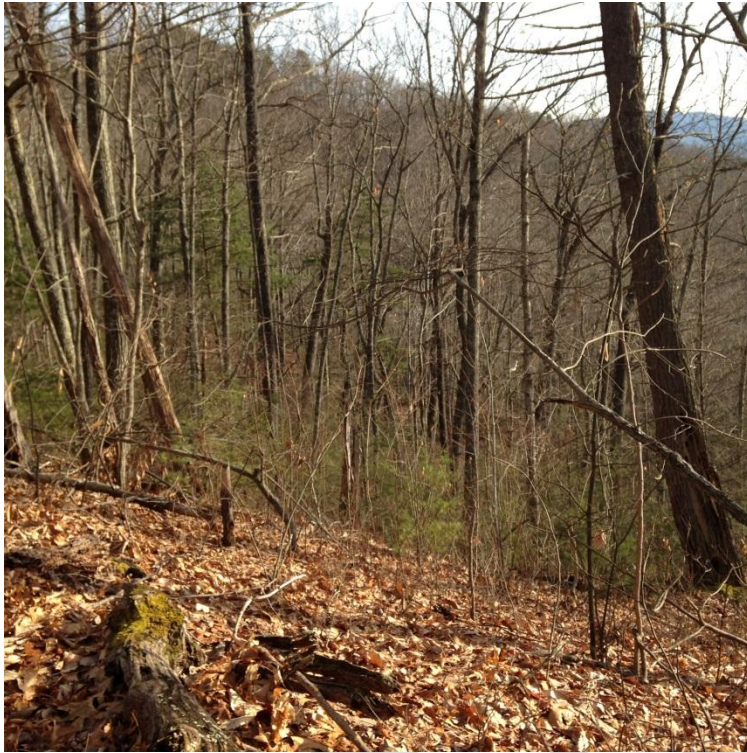
Figure 45. Eastern face of main ridge. Area mapped as Unicoi Rock Outcrop. This area may be traversed by a skid road built in compliance with project design criteria.

The steeper southern portion of the eastern face of the ridge may be traversed by a skid road to access the timber on flatter ground in the northeastern corner of the stand. If greater than 200 ft. long on a sustained side-slope greater than 40%, in compliance with project design criteria, interdisciplinary team approval will be required. Ground based equipment will be prohibited from operating on slopes greater than 40% on the southwestern and western faces of the ridge. Timber in these areas may be directionally felled and cabled up to the ridge or down to the road.

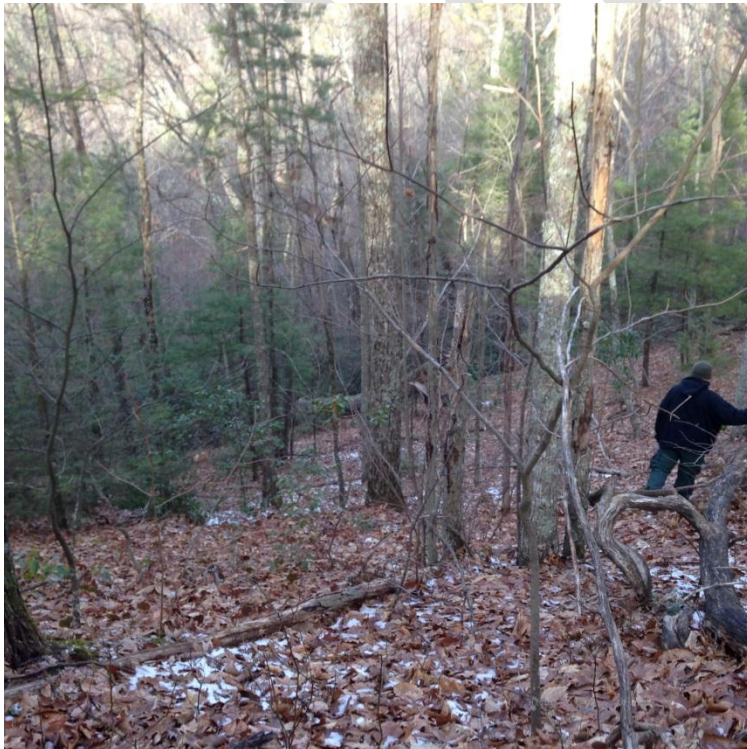
Figure 46. Western face of main ridge. Area mapped as Unicoi Rock Outcrop. Equipment would be prohibited in this area.

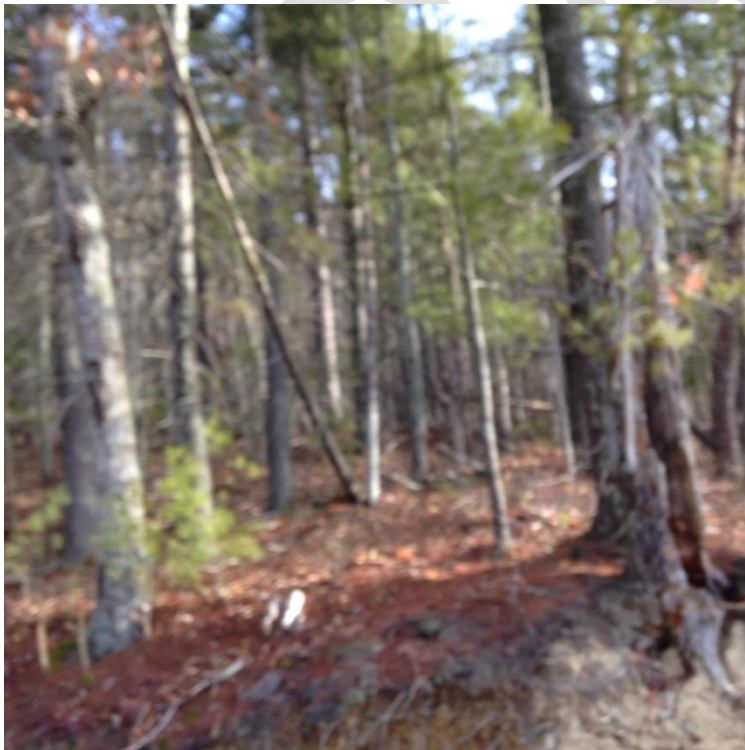
These stands are characterized by a main ridge running roughly northwest-southeast (mapped as Soco "F") and a secondary ridge running roughly northeast-southwest (mapped as Soco F). The slope of both ridges as measured in the field is approximately 35%. Slopes in the remainder of the area range from 45% to greater than 60%.

Figure 47. Secondary ridge mapped as Soco F.

Ground based equipment operation within these stands will be limited to the two ridges described above. Other areas are too steep for operation of ground based equipment.

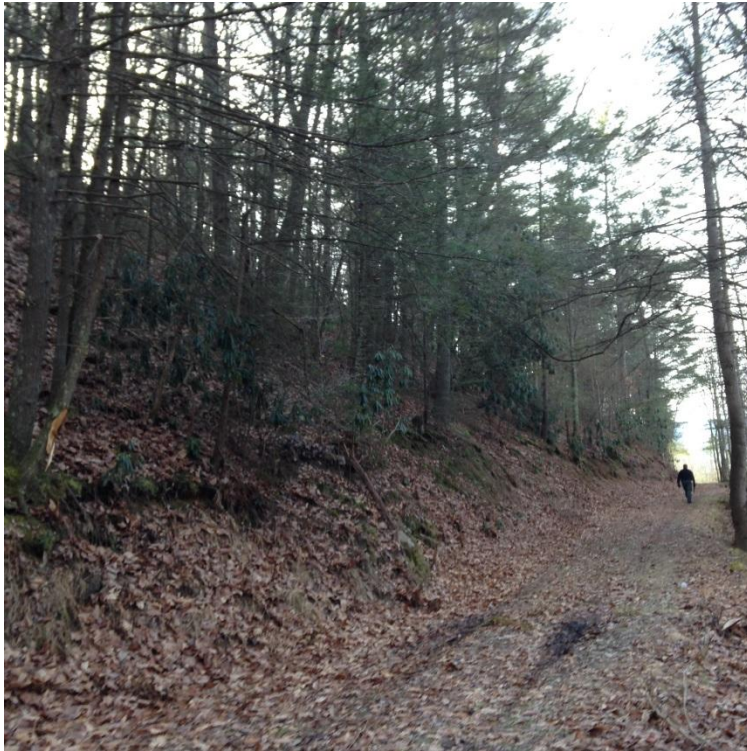
Figure 48. Terrain along southern edge of 214/26 is too steep for operation of ground-based logging equipment. Area mapped as Soco "F".

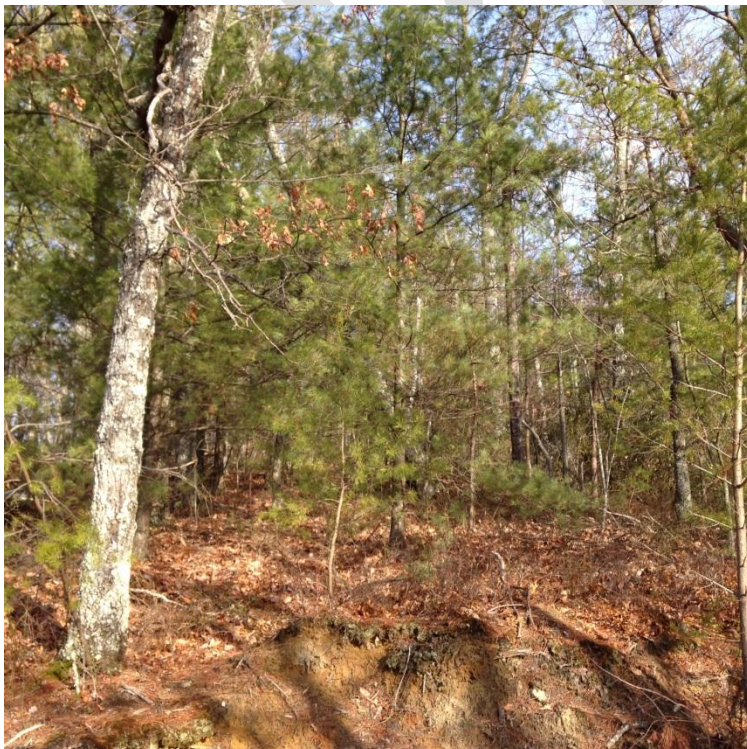
Figure 49. Main ridge mapped as Soco E (20-35%)

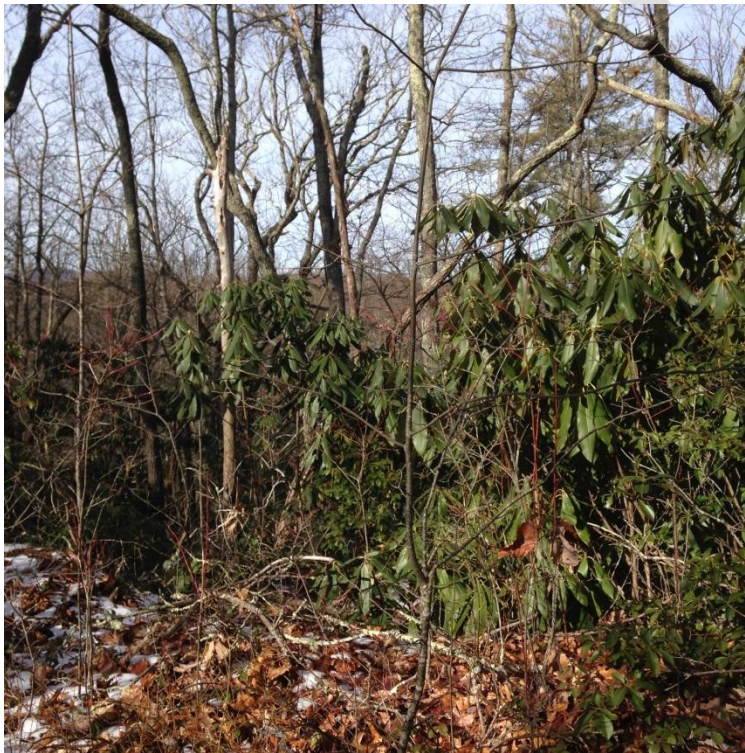
These stands were inspected and described together since they are contiguous and similar in both terrain and soils. These units run roughly northeast-southwest along a narrow ridge between Rough Branch and Devil's Kitchen Branch. The ridgetop is mapped as Junaluska-Brasstown D,E, and F. Portions of the stands extending down the north side of the ridge are mapped as Unicoi Rock Outcrop. In general, the ridgeline is gently sloping (less than 20%) and would be suitable for use of ground-based logging equipment. The side-slopes are much too steep for operation of ground-based equipment.

Figure 50. Slope break along northern side of ridge. Area mapped as Junaluska-Brasstown "F".

Any timber harvested past the slope-break would need to be cabled up to the ridge.

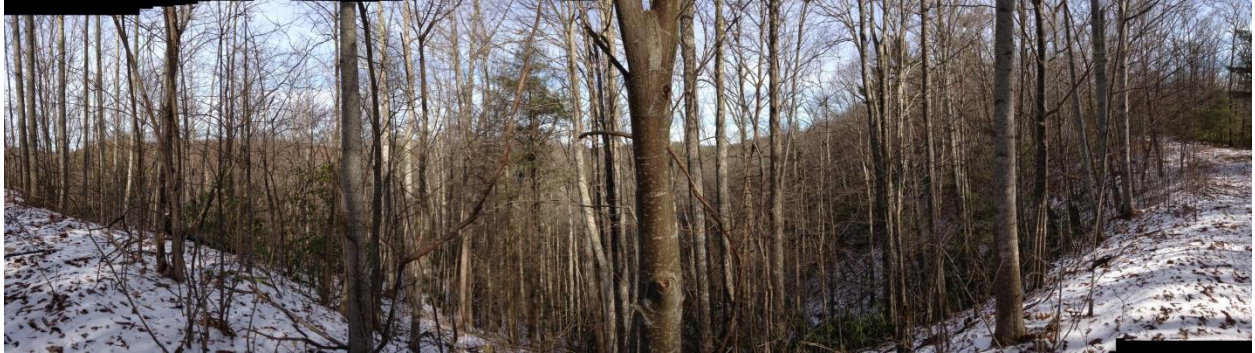
Figure 51. Panoramic view north into area mapped as Unicoi Rock Outcrop from existing road along gently sloping ridgeline

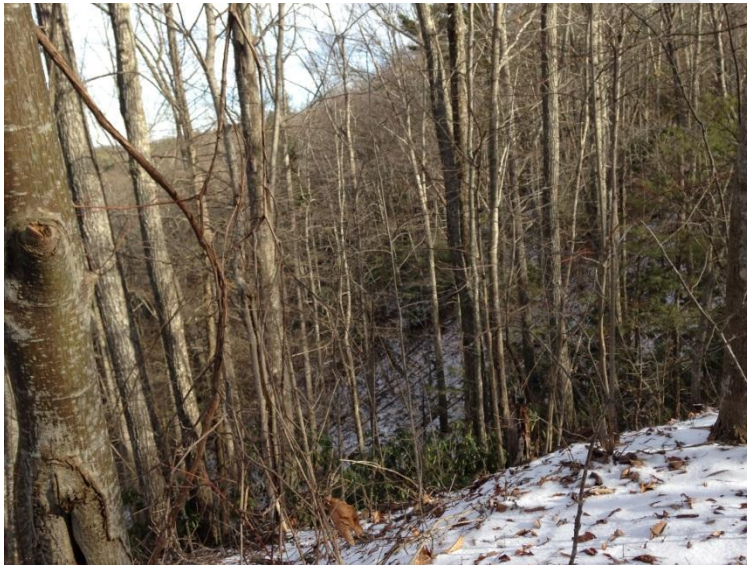
Figure 52. Steep side-slope along northern face of ridge. Area mapped as Unicoi Rock Outcrop.
